University of Minnesota Duluth

STORM WATER INSPECTION FORM

Outfall # : _____ Photograph Name : 03-ST4596- Inspection Date: 11/19/2003
 Pond Name: N/A
 Mechanical Structure # : ST4596 Type: Storm Cepter 900
 Location: Lot G
 Inspector: Erik J. Larson
 Weather: Air Temperature: 30 degrees Rain: Y N Date of Last Rain: 11/19 A.M. Sunny Cloudy
 Describe drainage area: North 1/2 of Lot G - Prior to underground storage system
 Shared Use: Y N Describe: _____

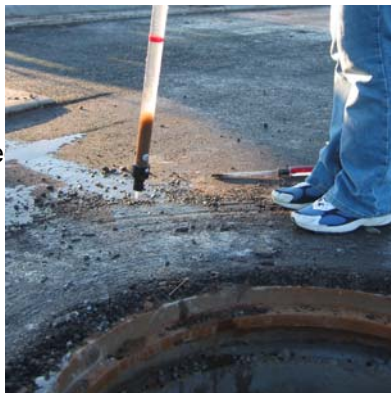
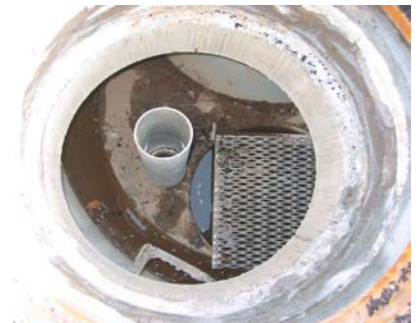
Comments / Recommendations	Completed	Date
New Construction Summer 03	Y N	_____
~Stormceptor has filled	Y N	_____
~Minor suspended solids in bottom of tank	Y N	_____
Depth of bottom of tank is 9'6" to north side of rim	Y N	_____
(nearest to oil port/through oil port)	Y N	_____
_____	Y N	_____
_____	Y N	_____
