Little Fork River Channel Stability and Geomorphic Assessment

Final Report

Submitted to the MPCA

Karen B. Gran, Brad Hansen, John Nieber

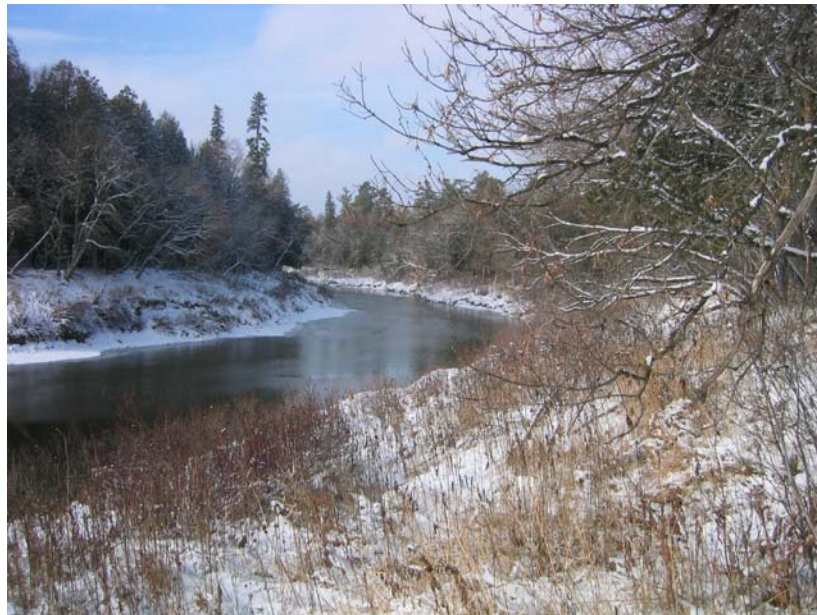
Figure 0.1: Photo showing the convex upwards banks with cutbanks near the water surface. This photo was taken during low flow at the Bois Forte site (RM 88), looking downstream.

In the Little Fork River, two primary observations can be made about the channel along much of its length downstream of Hannine Falls. First, the channel appears to be entrenched into its paleofloodplain. Second, slope and bank failures are apparent throughout the system. Many of the banks are vegetated with grasses, with trees more prevalent farther up the slope. Bank slopes are convex upwards but steep, often with vertical cutbanks near the water's edge (see Figure 0.1). Bank erosion happens both through erosion of individual grains near the toe of the bank as well as through large block failures that result as the bank oversteepens or is undercut. These larger failures include slumps and rotational failures that extend up the entire valley slope as well as localized bank failures (see Figure 0.1, 0.2).

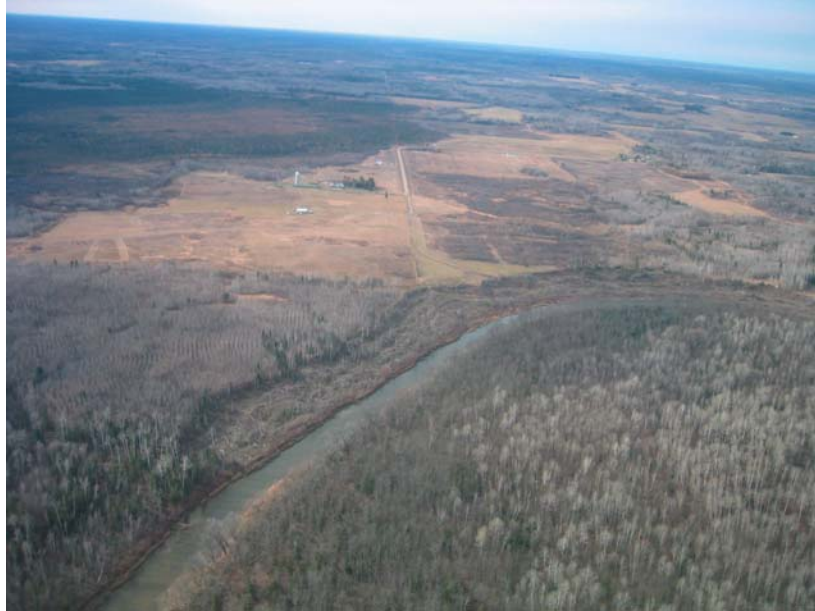
Figure 0.2: Large rotational failures and slumps extending up to the top of the slope break on the outside of a bend.

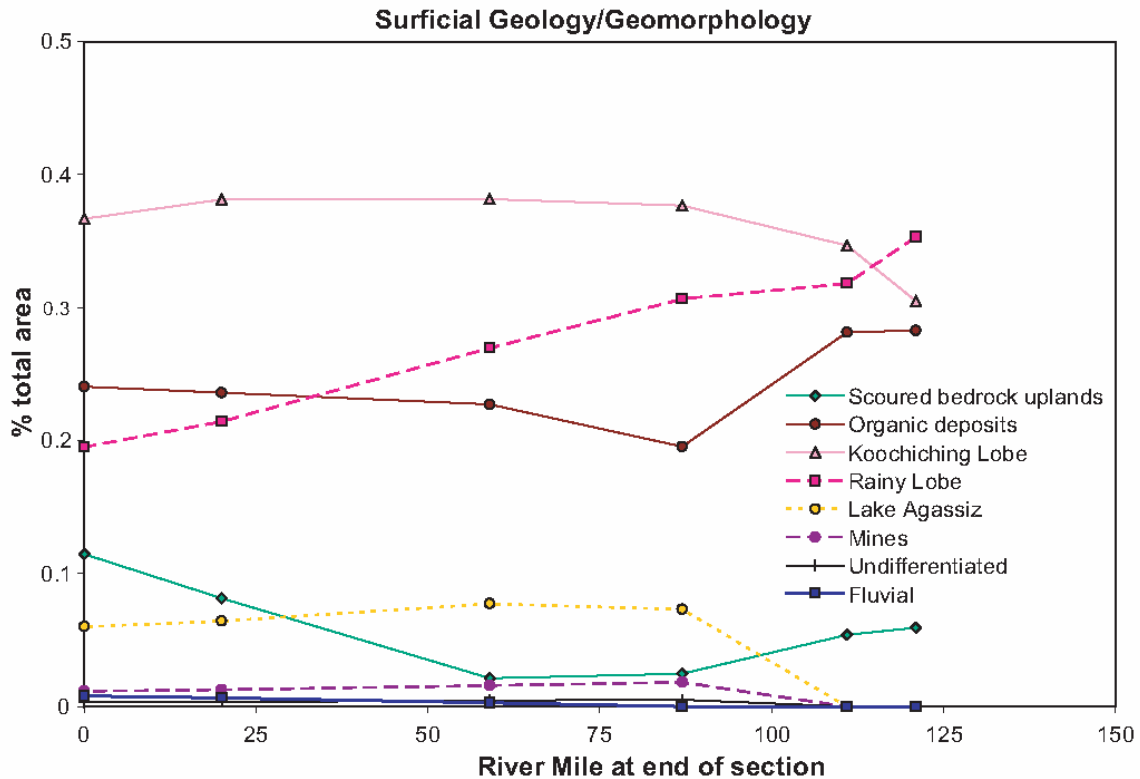
Figure 1.11: Surficial geology of drainage area contributing to each river section. Each section is plotted at the river mile on the downstream end, and the % area for each section represents the integrated total of the entire drainage area upstream.

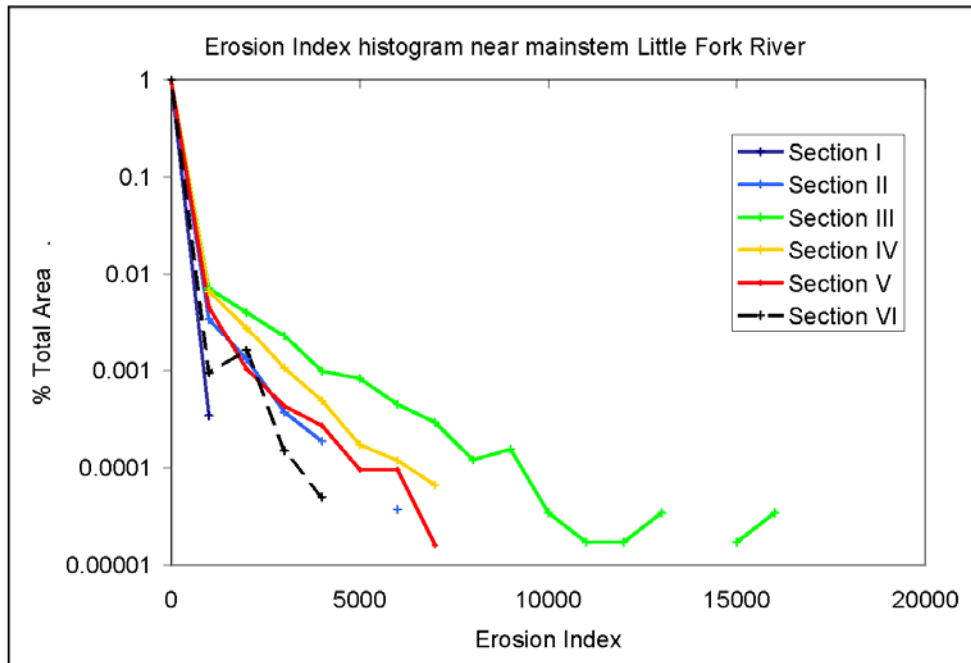
Figure 1.14: Histogram of EI values within 1km of the Little Fork mainstem channel. The EI values were binned at 1000 EI increments, and normalized to account for differences in area. Section III has the highest EI distribution.

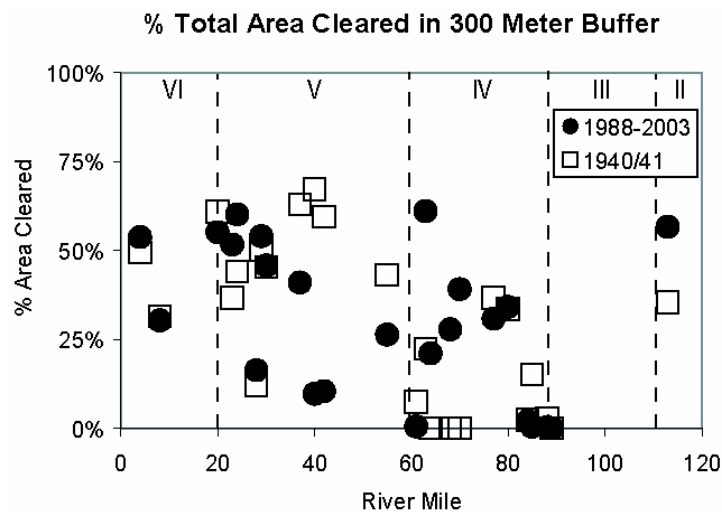
Figure 2.9: Area cleared within kilometer-long reaches in a 300-m buffer zone around the mainstem Little Fork River. The % area cleared includes areas logged and cleared for other purposes as a % of the total area within the reach.

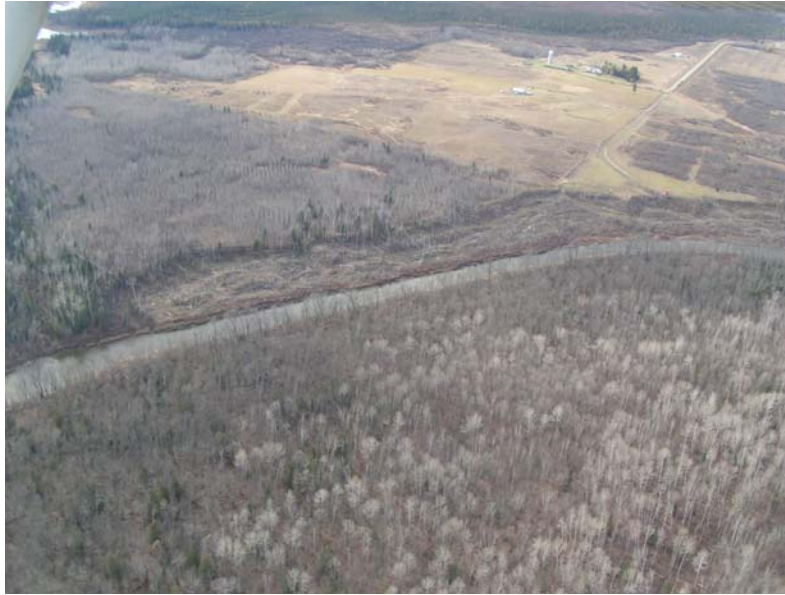
Figure 2.14: The outer edge of a meander bend has slumps reaching up to the top of the slope break.

Although these comparisons are useful, they are limited in scope due to the sparse number of visible slope failures, bank failures, gullies, or ravines visible in these photographs. To gain a broader perspective on slope and bank failures throughout the basin, I examined the parts of the landscape most susceptible to slope or bank failures: locations where meander bends abut steep, valley walls. In these areas, undercutting at the toe of the slope by the migrating river can trigger slope failures up to the top of the slope (see Figure 2.14). I cataloged outer bends throughout the mainstem from RM 115

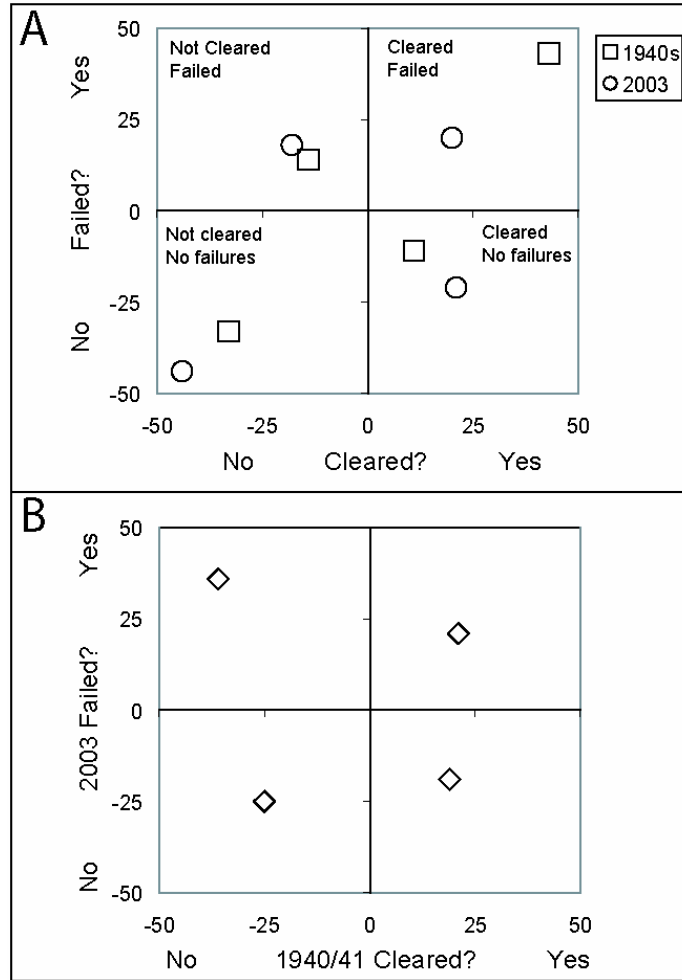
Figure 2.15: Matrices showing number of outer bends with and without forest clearing and with and without visible slope or bank failures. A) Bend conditions in 1940/41 and 2003 are plotted, showing a significant correlation between land clearing and visible failures. B) Land clearing in 1940 was compared with visible failures in 2003 with no significant correlations.

Overall, slope or bank failures were visible on 53% of all outer bends migrating into steep valley walls in the 1940s. In 2003, that number had dropped to 40% of the bends. This did not include bends where steep slopes were set back from the river, which are prevalent in the lowlands of Sections V and VI. It also does not include bends migrating into low valley walls or floodplain deposits. The number of visible failures mirrors the distribution of bends with full or partial clearing (56% in 1940s and 37% in 2003) which both increases the risk of slope failures and makes them much easier to see on aerial photographs.

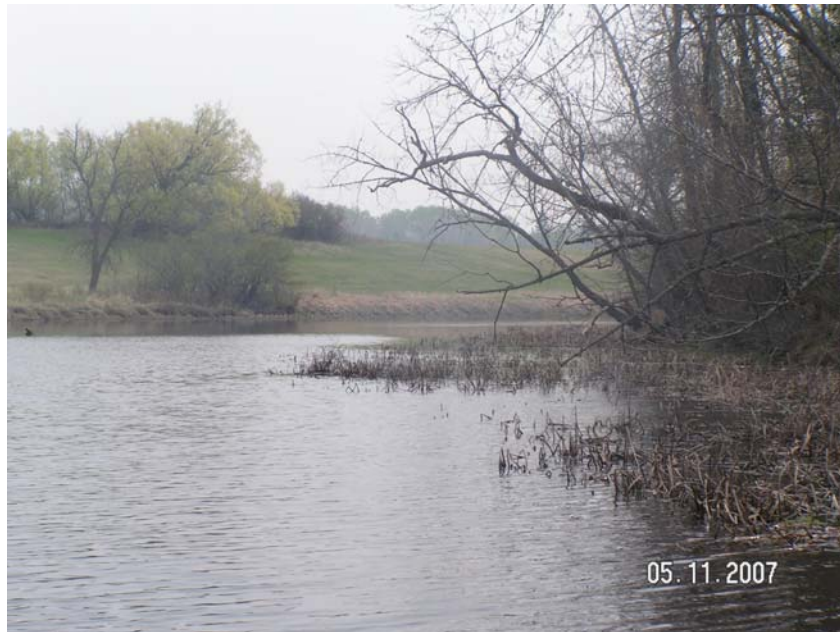
Figure 3.1: Upstream of Hannine Falls, near RM 124. Bulrushes growing on the edges of the channel indicate a shallow, submerged bench rather than the steep, near vertical channel side slopes seen further downstream. The floodplain is accessible in this area.

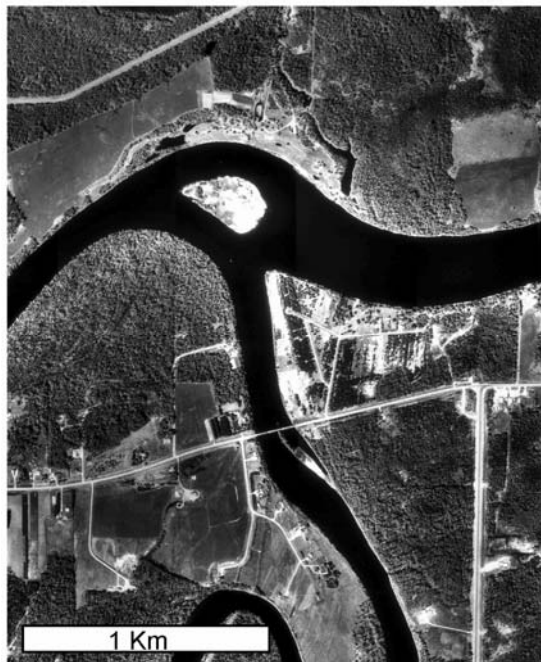
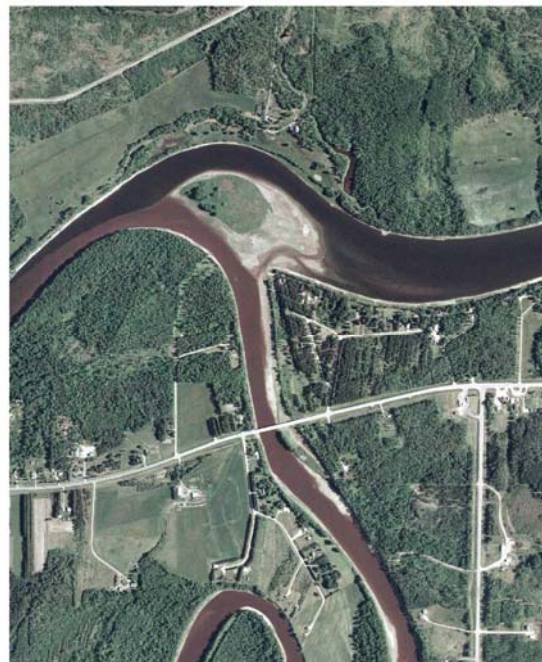
Figure 3.4: Mouth of the Little Fork River at the Rainy River confluence. In 2003 (right), water levels are low, exposing the Little Fork delta and part of the floodplain on the right bank side of the river. At the time photos were taken in 1991, the delta and floodplain were both inundated.

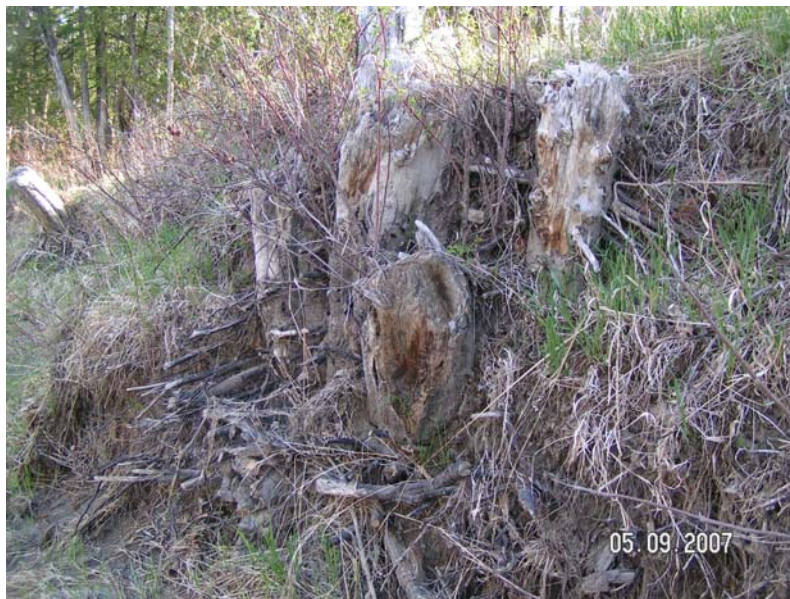
Figure 3.5: Buried stumps at Fielder Landing (RM 43).

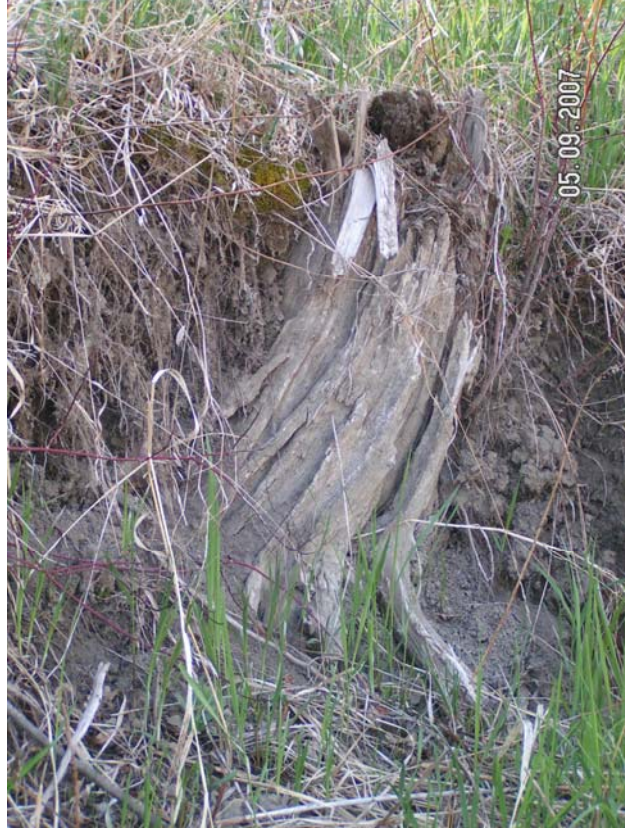
Figure 3.6: Close-up of a buried stump at Fielder Landing (RM 43).

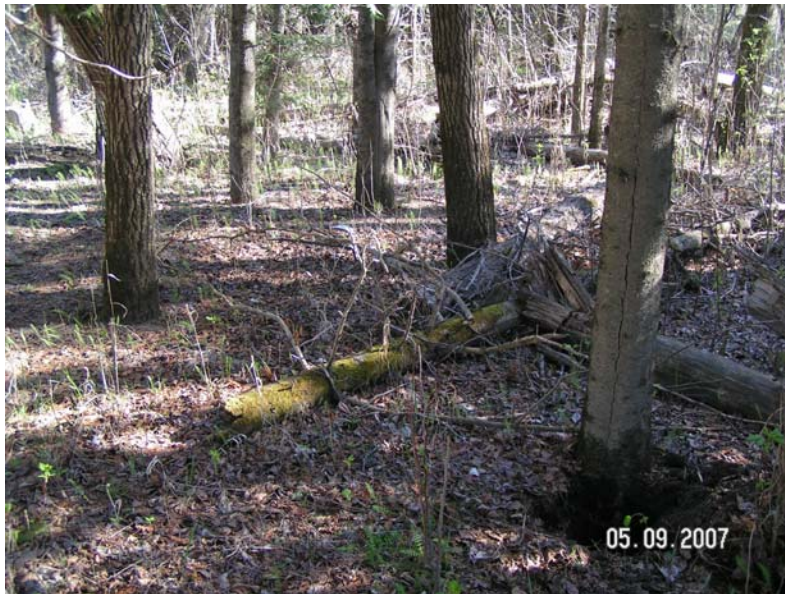
Figure 3.7: Trees with buried root crowns at Fielder Landing (RM 43). The tree on the far right was excavated, and the root crown was not found in the top 1 m.

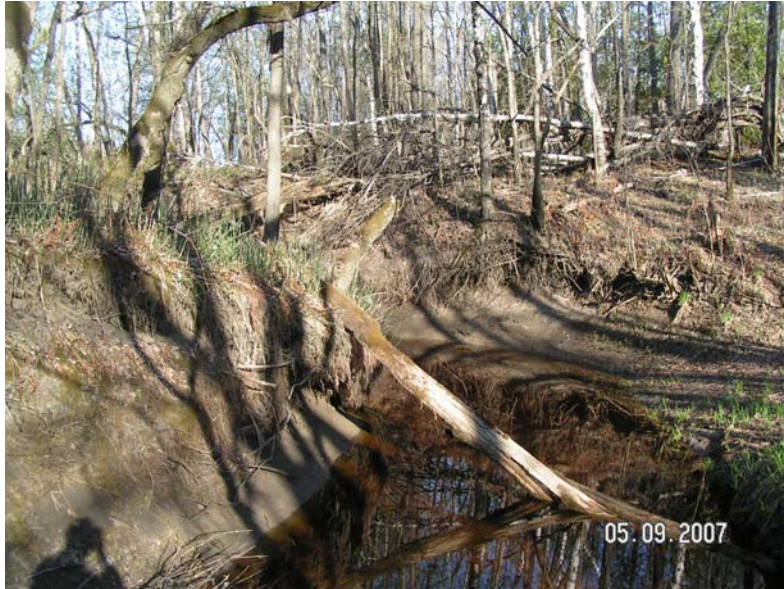
Figure 3.8: Tributary to the mainstem Little Fork River just downstream of Fielder Landing (RM 43). The tributary shows signs of incision, with no evidence of a current active floodplain.

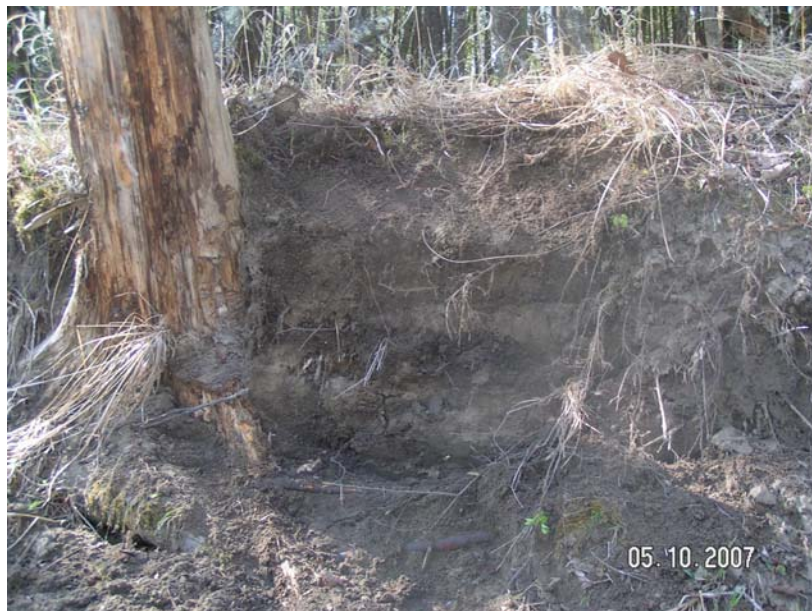
Figure 3.9: Tree crown buried under ~ 1 m of sand at RM 110, just downstream of the Sturgeon River confluence.

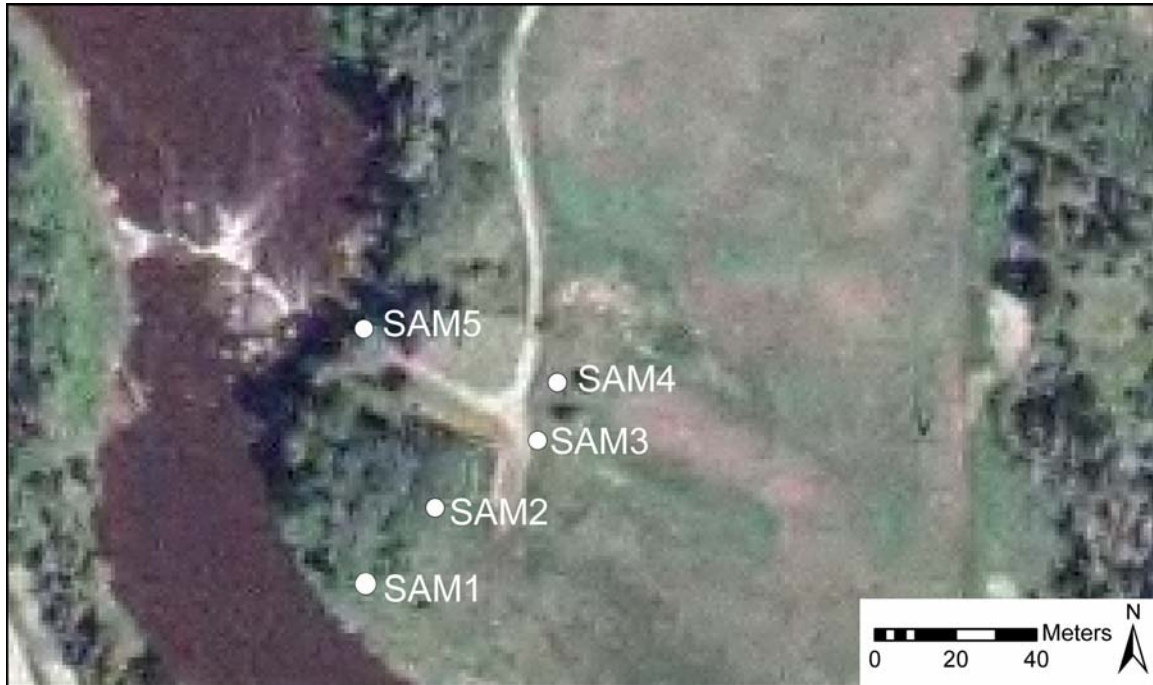
Figure 4.2: Location of cores collected from Samuelson Park, RM 101, TR Section.

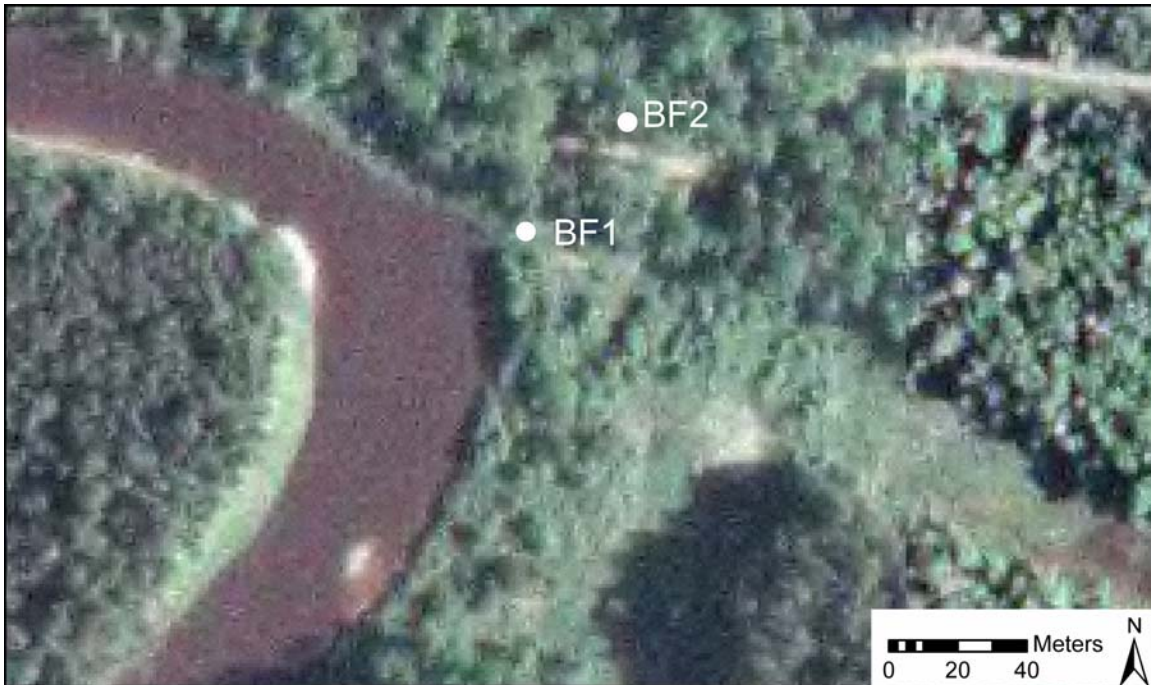
Figure 4.3: Location of sediment cores collected from Bois Forte site (RM 88).

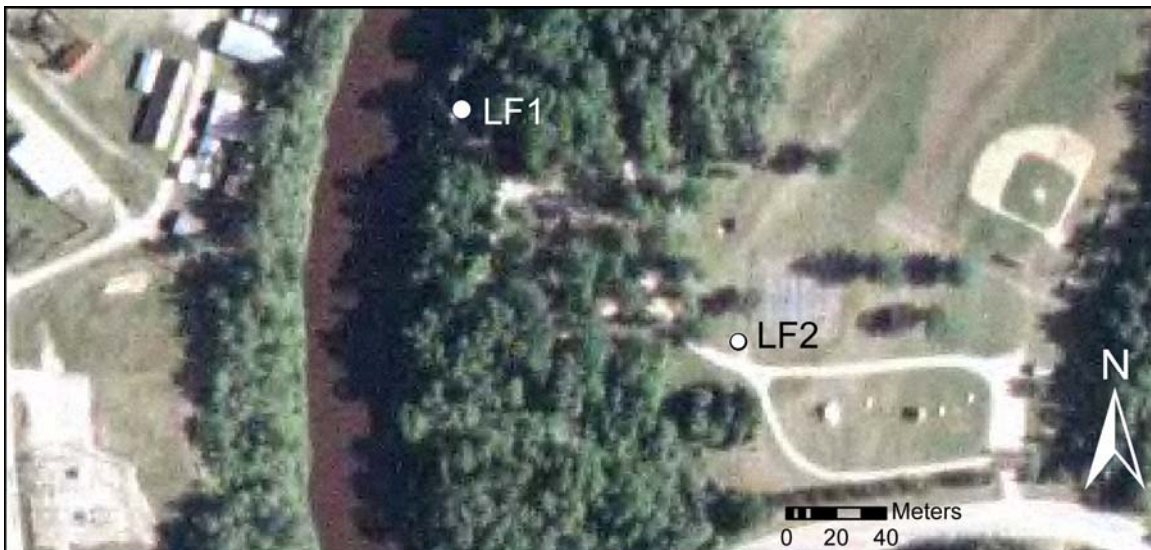
Figure 4.4: Location of sediment cores collected from Lofgren Park in the town of Littlefork (RM 20). LF-1 was 3-4 m from the slope break at the channel edge. LF-2 was on the next terrace up in elevation.

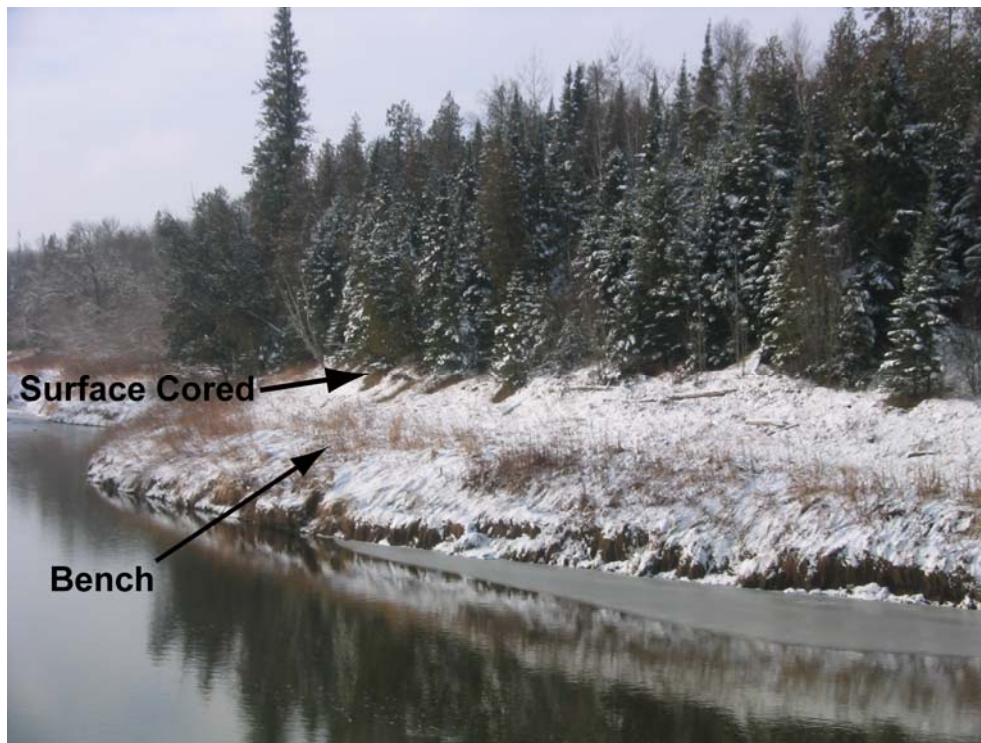
Figure 4.5: Left bank of Little Fork River at Bois Forte site. We cored the upper surface on the right-bank side of the channel. This was 2.9 meters above the low bench seen here on the opposite bank. The coring location was on the outside of a meander bend, and the low bench was narrower on the right-bank side.

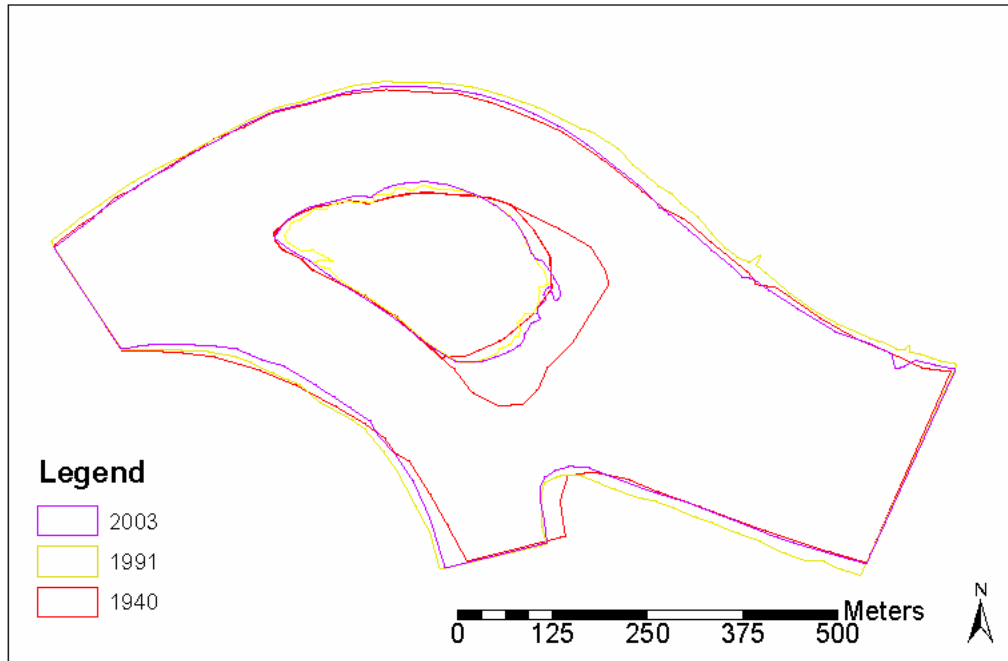
Figure 5.2: Traces showing the location of the mid-channel island in 1940, 1991, and 2003. In 1940, it was difficult to determine the slope break, so both the estimated slope break and the edge of the vegetation were digitized in.

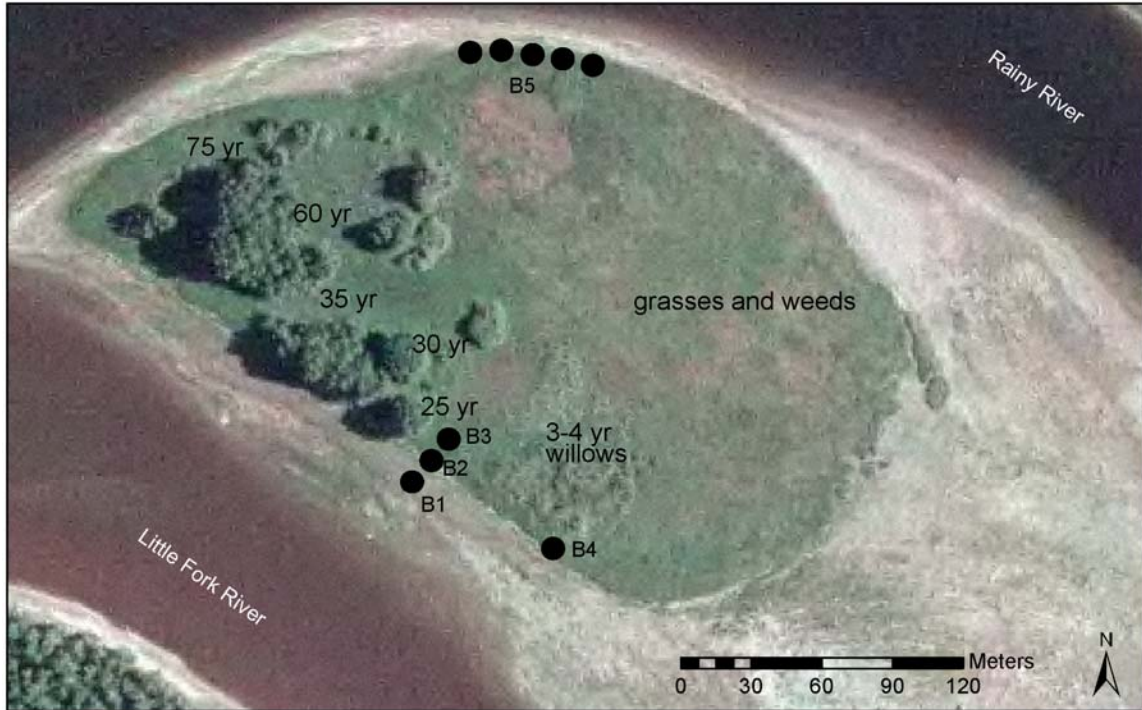
Figure 5.3: Location map of island showing trees that were cored (labels are offset from the actual trees cored) and locations of soil cores/pits (B1-B5).

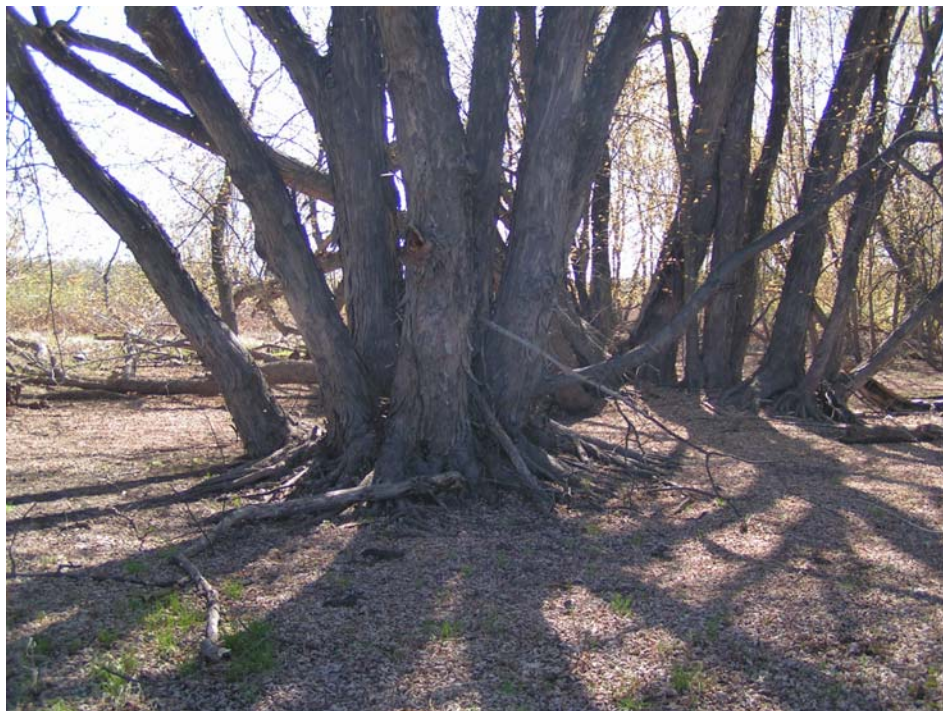
Figure 5.4: Trees on the island tend to grow in clumps, which may help protect them from ice damage during high flows.

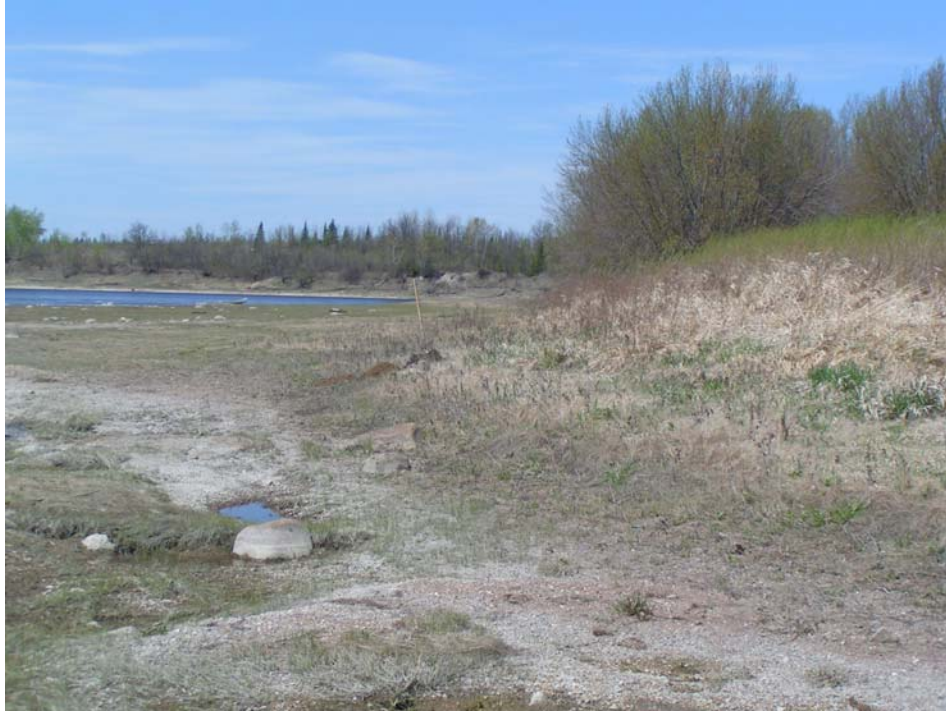
Figure 5.5: Rise on the south side of the island. The pole sticking up marks the location of a soil pit (B2).

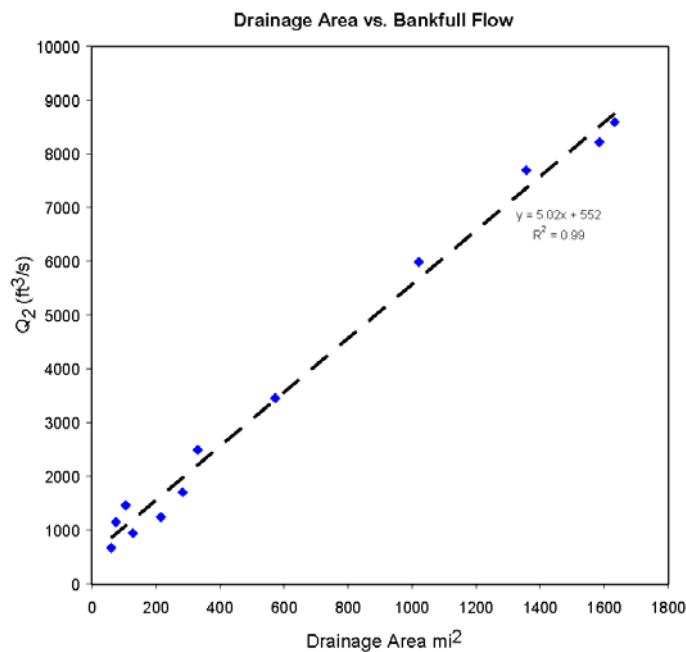
Figure 5.3: Relationship between drainage area and Q_2 in the Little Fork River basin.

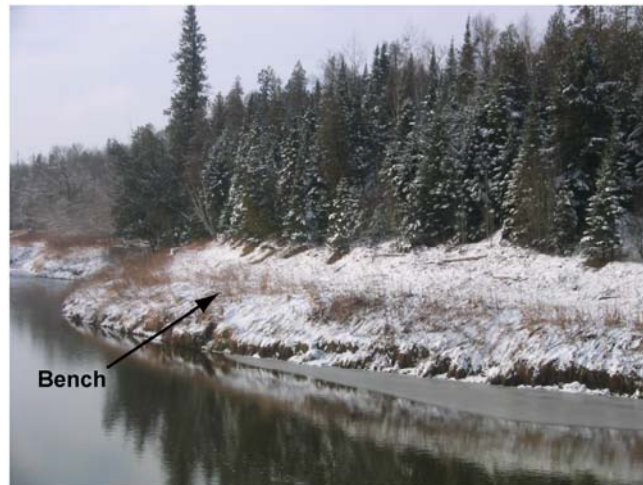
Figure 5.4: Bankfull bench near RM 88.

Potential bankfull elevations were determined in the field visually using clues from vegetation, fresh deposition, or topographic benches or low surfaces (see Figure 5.4). These correspond to the elevation reached by the current channel-modifying flow. Elevations of terraces adjacent to the channel were also surveyed or estimated in the field. Terrace heights (D_{terr}) were compared with two times the bankfull depth (D_{bf}) as a proxy for measuring an entrenchment ratio. The classic entrenchment ratio is a measure of the channel width at $2*D_{bf}$ vs. the channel width at D_{bf} (Rosgen, 1994). Here, we compare $2*D_{bf}$ with D_{terr} (see Table 5.3 and Figure 5.5). The elevation of $1.8*D_{bf}$ is the approximate depth of a Q_{50} flood event based on streams in the eastern United States (Leopold et al., 1964), so $2*D_{bf}$ represents a depth greater than the Q_{50} flood depth.

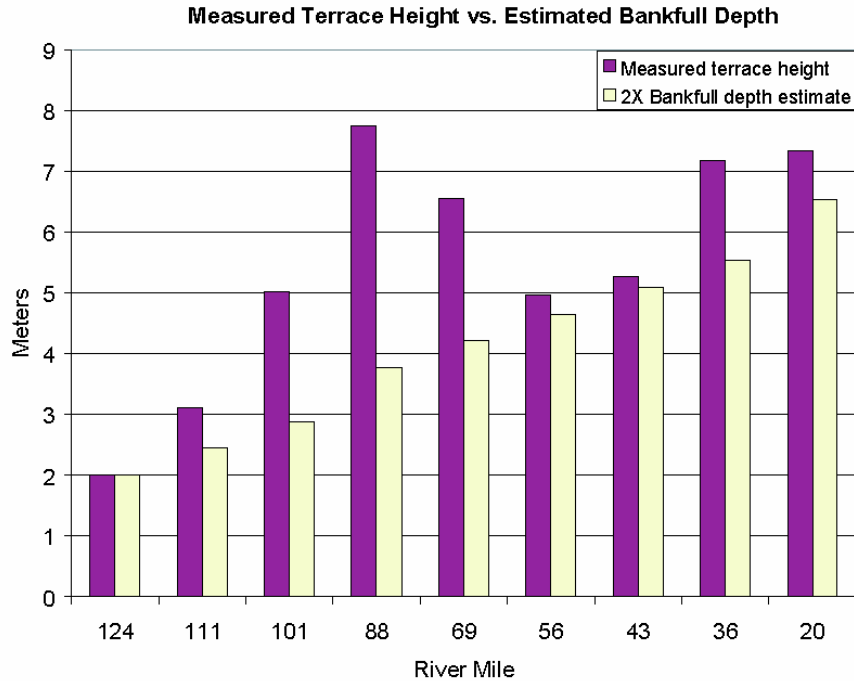
Figure 5.5: Relationship between measured terrace heights and estimated bankfull heights. Bankfull heights were estimated visually based on developing benches, recent deposits on surfaces, and vegetation changes. Plotted here are $2 * D_{bf}$ vs. D_{terr} .

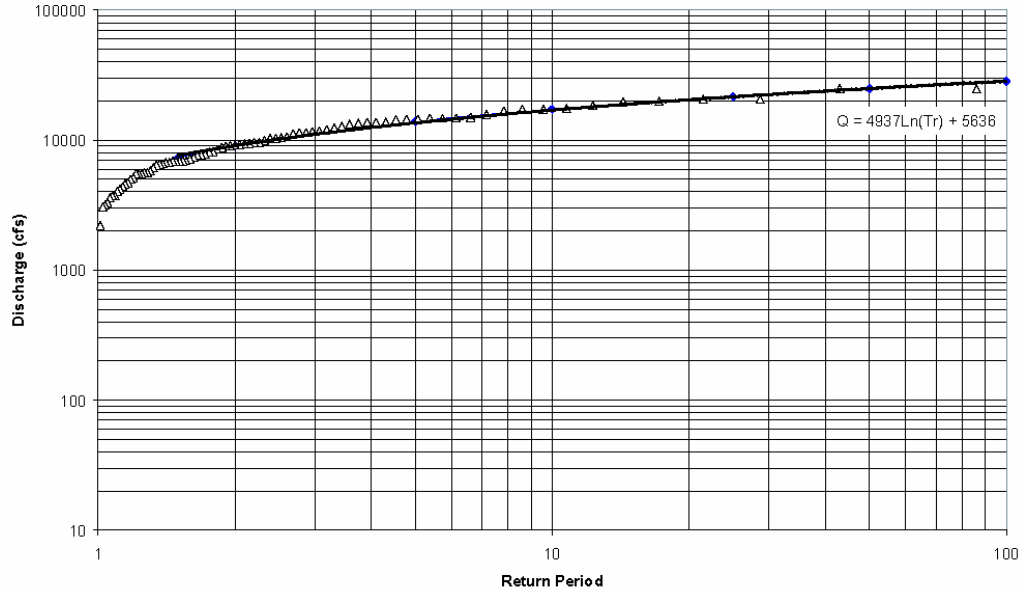
Flood Frequency Little Fork River at Cook
1.5yr = 450 cfs

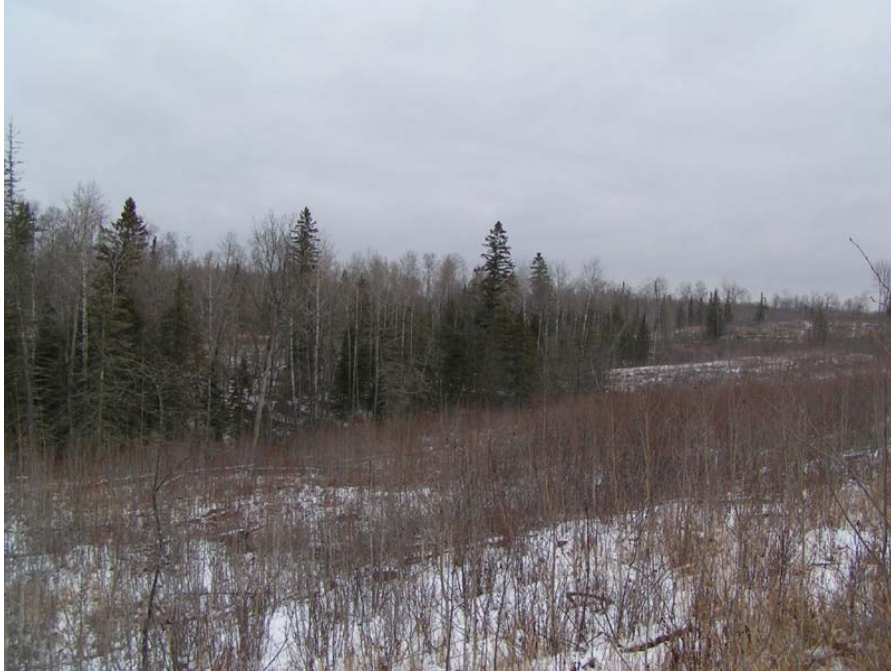
Photo 1: Tributary running through Nandrasy property. Hillslopes were logged in 2001.

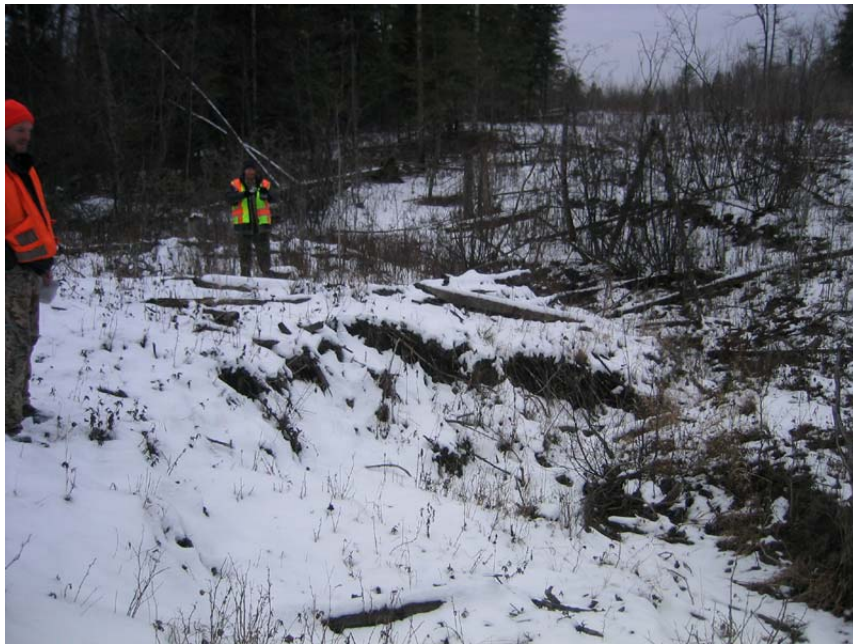
Photo 2: Tributary at the logger's crossing zone. Note downed trees in the channel and a large slumped bank on the left side.

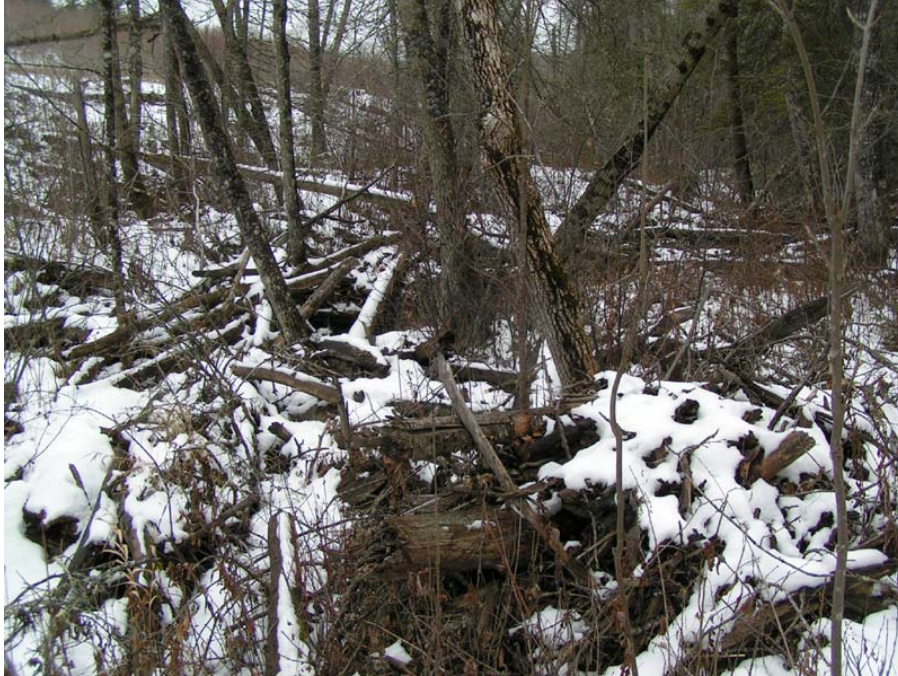
Photo 3: Slash in tributary channel.

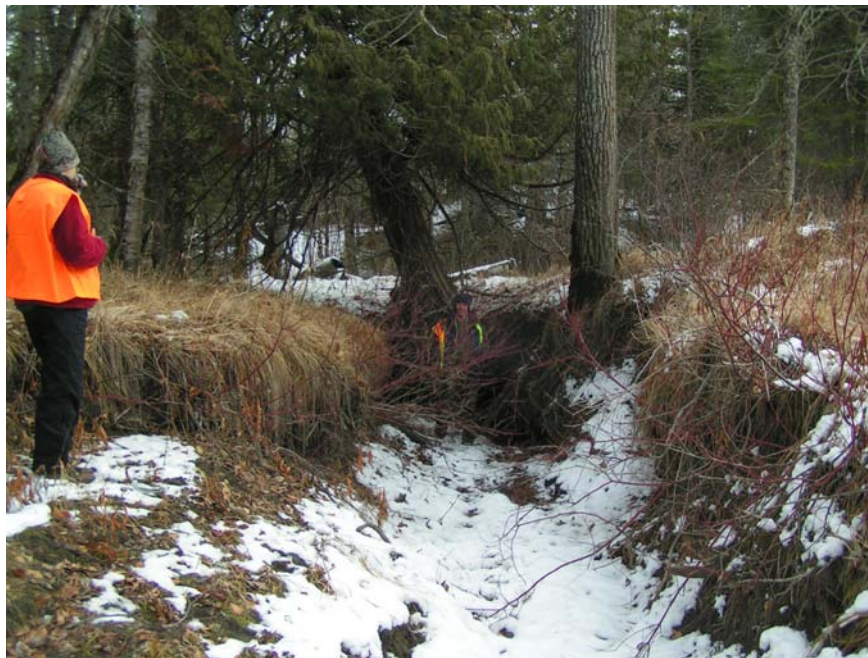
Photo 4: Confluence with Little Fork River (looking upstream). On the left is the fresh deposit of mud and silts. In the middle is a cedar tree that is significantly undercut (close-up in Photo 3).

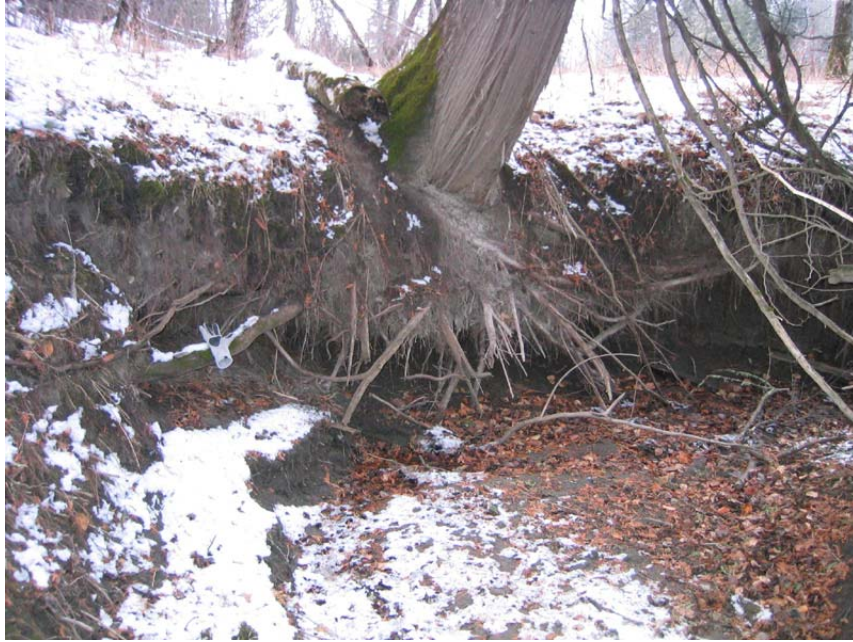
Photo 5: Cedar tree undercut by recent erosion. Erosion extends back several feet. On the far left is a slump deposit comprised of fine-grained materials.

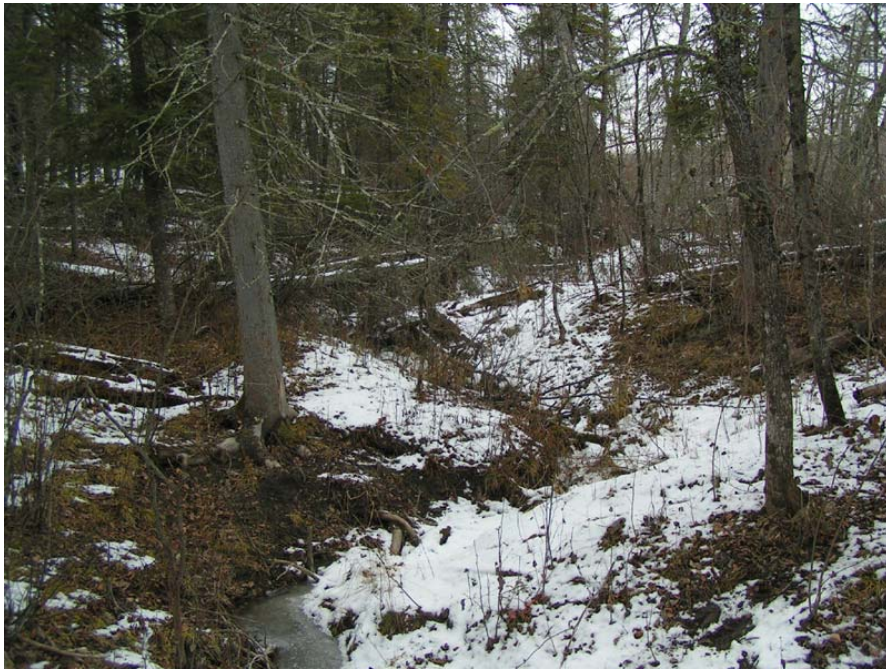
Photo 6: Meandering tributary upstream of confluence. Downstream of this photo, meander sinuosity increases greatly, with tight, looping meanders. Incision is greater in the downstream reach than in this reach.

Another interesting feature of the lowermost tributary was its highly sinuous nature. After 3-4 large, looping meander bends, the sinuosity decreases upstream (see Photo 6 of upstream reach). The depth of the channel was approximately 5-6 feet in the highly sinuous lower reach, decreasing to 3-4 feet as the sinuosity changes upstream, although the width did not appear to vary greatly.
