# **Development of Flexural Vibration Inspection Techniques to Rapidly Assess the Structural Health of Rural Bridge Systems**

## **Final Report**

## **July 2008**

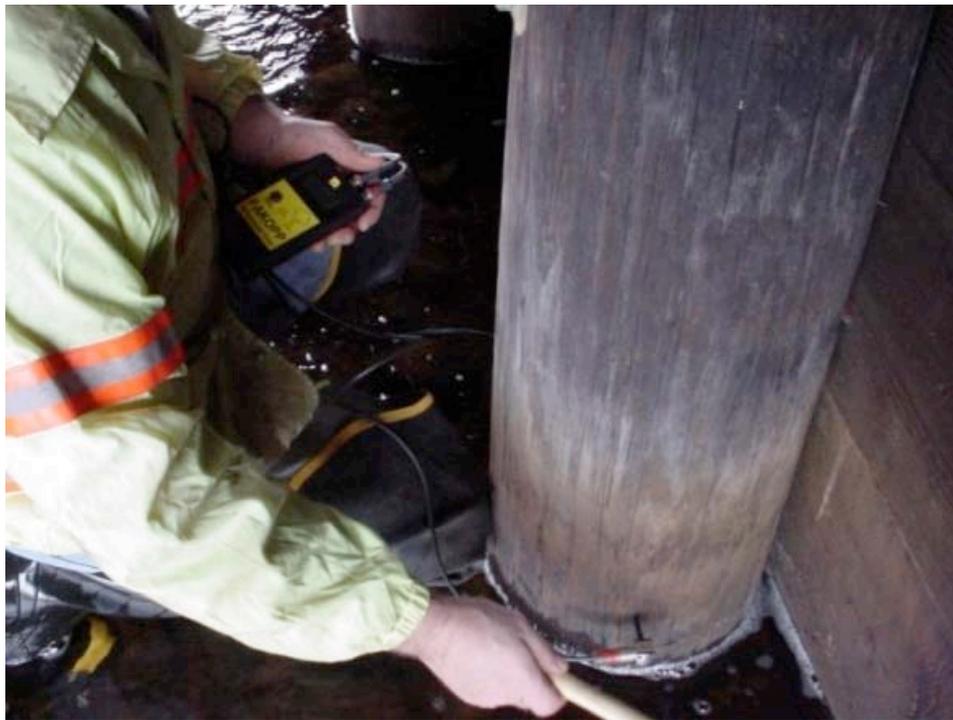
**Figure 3.1.** Fakopp microsecond timer being used on a timber pile.

A Fakopp Microsecond Timer was used to determine the stress wave time across the piling 6 inches above the water line, at 6 inches below the pile top and at a point midway between these two measurements. The Fakopp was also used to test the pile caps at several locations, starting on one end continuing along its length at locations between the stringers. It was also used to test the girders 12 inches away from the end above the abutment.

The Fakopp is very accurate at determining the presence of decay at the testing location and is useful in mapping the decay locations. Table 3.1 shows the stress wave transmission times perpendicular to the grain for several species at various degradation levels for the species present in the timber bridges.

In areas of concern noted during visual and stress wave inspections, the IML F-300 resistance drill was used to test the cross-section and determine the resistance of the wood to a small diameter drill bit. An example of the Fakopp testing is shown in Figure 3.1 and the resistance drilling testing in Figure 3.2.

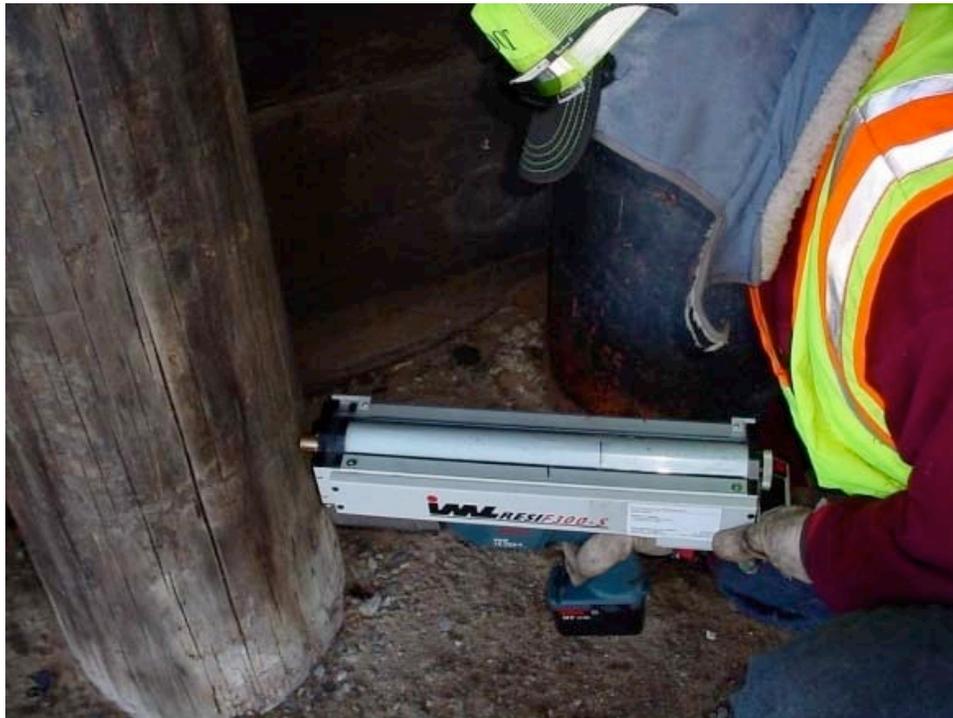
**Figure 3.2.** Example of resistance drill testing.

Resistance microdrilling was used to identify and quantify decay, voids, and insect galleries in wood beams, columns, poles, and piles. The resistance drill system measures the resistance of wood members to a 1.5-mm drill bit with a 3.0-mm head that passes through them. The drill bit is fed at a fixed movement rate allowing the inspector to determine the exact location and extent of the damaged area. This system produces a chart showing the relative resistance over its travel path. This chart can be produced either as a direct printout or can be downloaded to a computer. Areas of sound wood have varying levels of resistance depending on the density of the species and voids show no resistance. The inspector can determine areas of low, mild, and high levels of decay. A detailed explanation of the use of resistance microdrilling and interpretation of the testing is detailed in publications prepared by Brashaw et al (2005).

The resistance drilling unit was very accurate at determining the presence of decay at the drilling location. It measures the resistance on a 0-100% amplitude scale. Typical measures of resistance for sound softwoods are > 25%, 10-20% for moderate decay and 0-10% for advanced or severe decay.

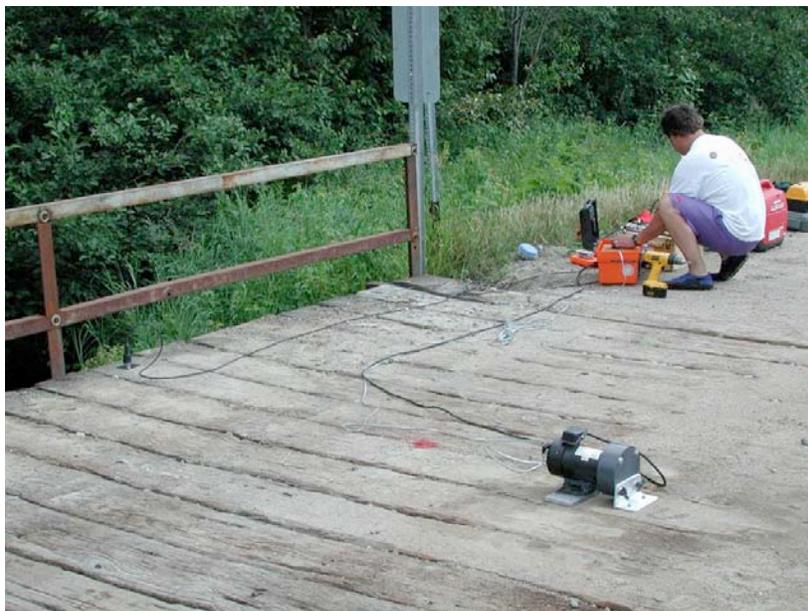
**Figure 3.3.** General test setup for vibration testing.

A forced vibration technique was used to identify the first bending mode frequency of the bridge structures. This method is a purely time domain method and was used because it eliminates the need for modal analysis. An electric motor with a rotating unbalanced wheel was used to excite the structure, which creates a rotating force vector proportional to the square of the speed of the motor. Placing the motor at midspan ensured that the simple bending mode of structure vibration was excited. Three piezoelectric accelerometers (PCB 626BO2), also at midspan, were used to record the response in the time domain. To locate the first bending mode frequency, the motor speed was slowly increased from rest until the first local maximum response acceleration was located. The period of vibration was then estimated from 10 cycles of this steady-state motion as captured using a Fluke digital scopemeter. The specific testing steps included:

1. Secure a dc motor (1/2 horsepower) with rotating unbalanced wheel to the deck plank at the center of the bridge span and anchor using steel bolt screws.
2. Secure two magnetic metal plates to deck plank, one on each side of the bridge at midspan using steel bolt screws.
3. Attach one piezoelectric accelerometer to each magnetic metal plate to monitor the bridge vibration signals.
4. Start up motor. Slowly increase motor speed to put the bridge into low frequency transverse vibration.
5. Find the first bending mode frequency by locating the first local maximum response acceleration using a digital scopemeter.
6. Record the data and start a second test.

Once all of the tests have been completed, the data is reviewed briefly and photographs are taken before leaving the test site. The typical test setup can be seen in Figure 3.3.

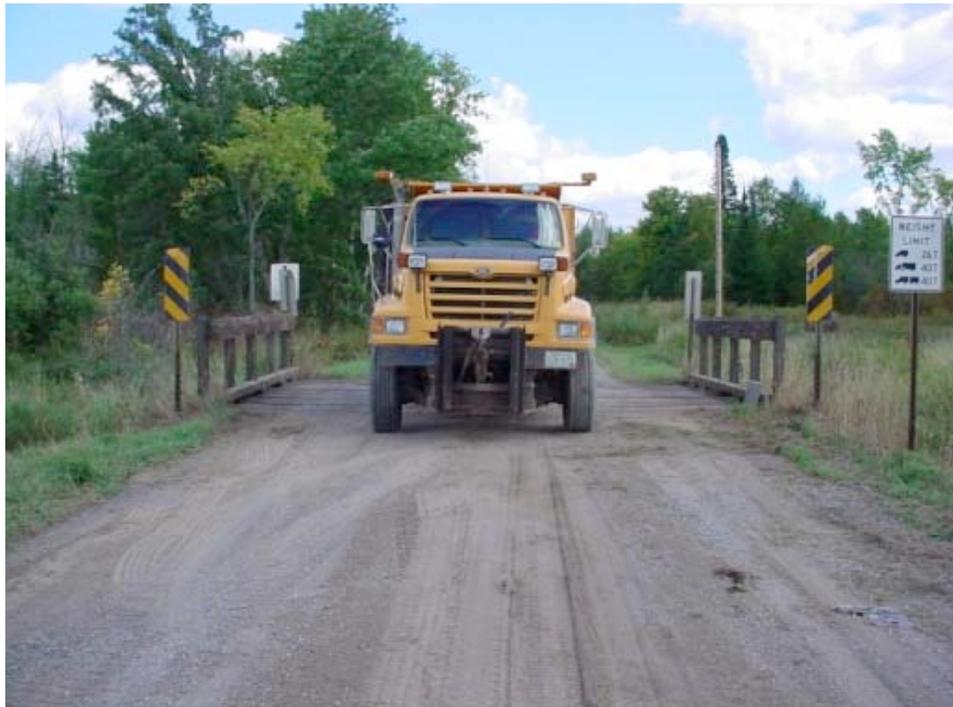
**Figure 3.4.** Truck positioned on bridge.

1. Position truck.
2. Take photograph.
3. Take deflection readings.
4. Check survey level bubble to ensure level.
5. Repeat sequence until testing is complete.

Once all of the data has been collected, it is reviewed briefly before the truck leaves for home. Photographs of the bridge, both end and side views, are then taken with no people, vehicles, or anything else on the bridge. The main components of the setup for load testing can be seen in Figures 3.4, 3.5, and 3.6.

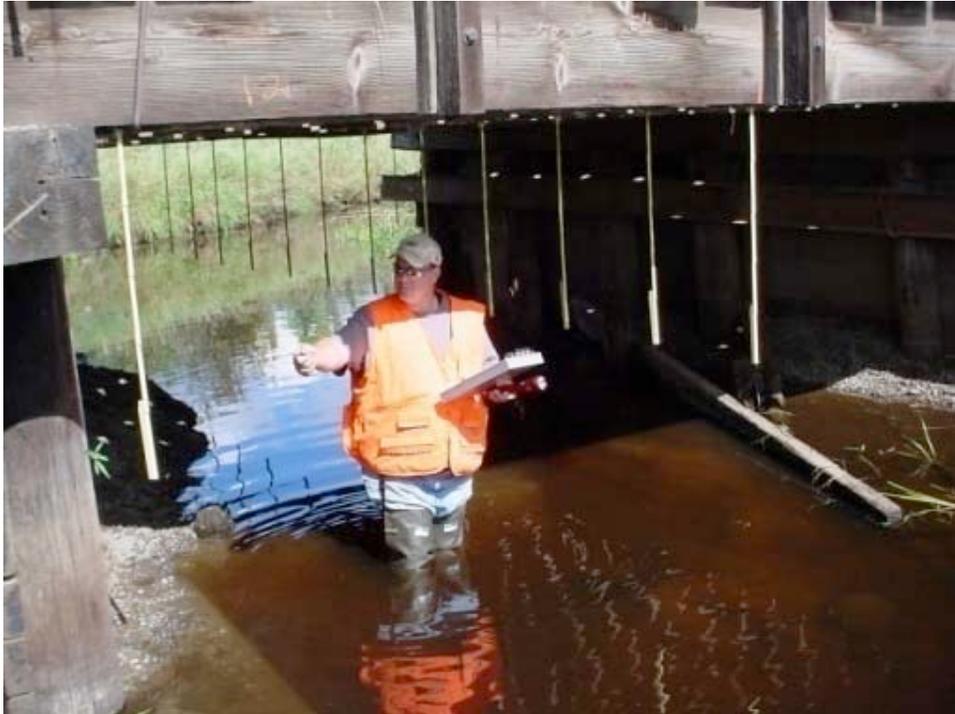
**Figure 3.5.** Deflection rulers.

1. Start with *UNDERSIDE* measurement of the bridge.
2. Measure (face-face) support span lengths along both edges of bridge, then place mark or nail at midspan location.
3. Measure beam, plank dimensions, and note any unusual repairs.
4. Measure all support bearing lengths for the abutment cap and pier cap beams.
5. Measure (center-center) spacing of all bridge beams at centerspan x-section.
6. Attach brackets and rulers near the center of each beam along the centerspan x-section.
7. Attach brackets and rulers near the support corners (and near centerline for wide bridges) of the span and make sure level instrument can read them ok.
8. Using a plumb bob, transfer the midspan x-section to the deck or curbs.
9. Continue with *TOPSIDE* measurements of the bridge.

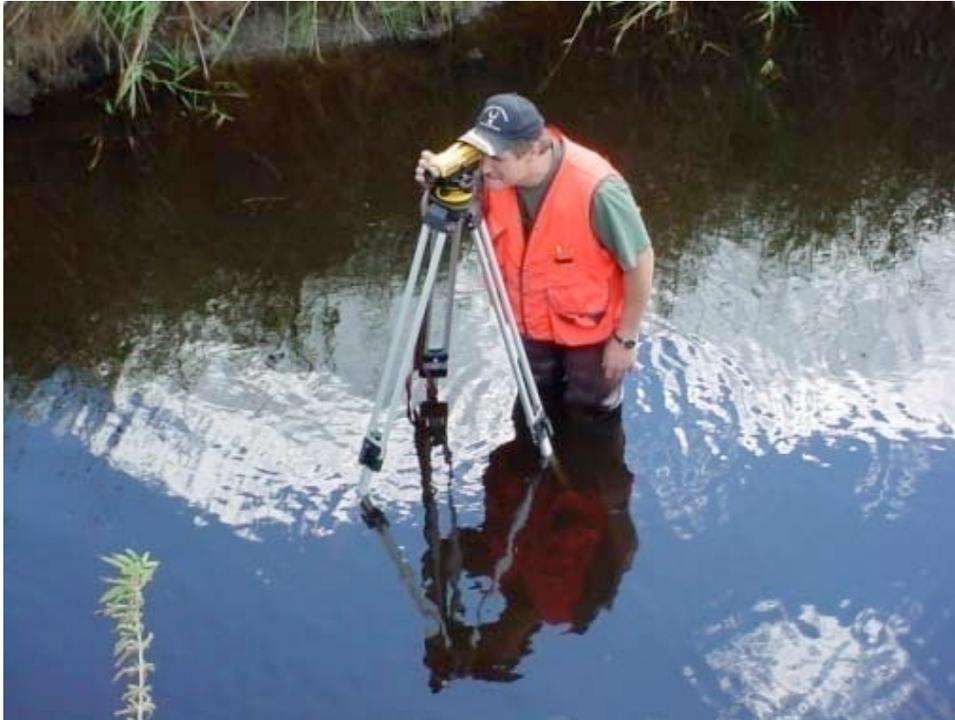
**Figure 3.6.** Optical surveying level.

1. Look for a suitable location on solid ground, not on soft soils or muck.
2. Ensure that the technician has a good view of all centerspan rulers, including the closest and farthest sight distances.
3. The height of instrument should be as high as possible, but not higher than 1 foot from top of deflection rulers.
4. Ensure that the operator has sight of four corners of each span tested to measure for possible vertical support movements.

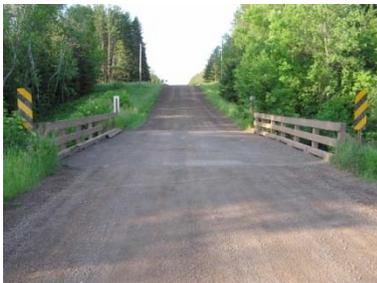
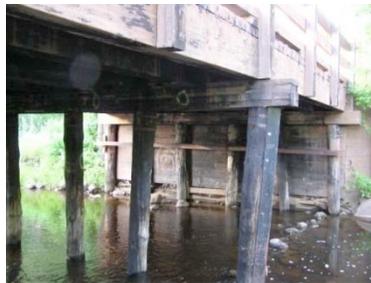
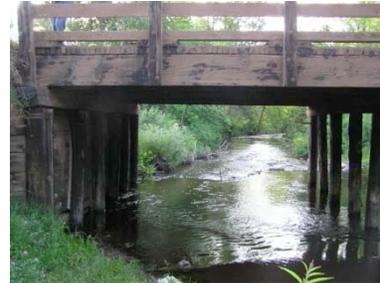
#### Bridge Photos:

Structure: Bridge 85  
Location: County Road 258, Duluth, Minnesota  
Special Consideration(s): None  
Estimated age: 1946  
Inspection date: July 2005  
Construction details: Two span; heavy timber pilings with Douglas fir girders/stringers and a wood/asphalt deck for a running surface
